Manhole Inspection Summary

Manhole # S59I__008MH

Insp Date: **5/15/08 2:56 PM**

Location Address: **4719 eastern ave**

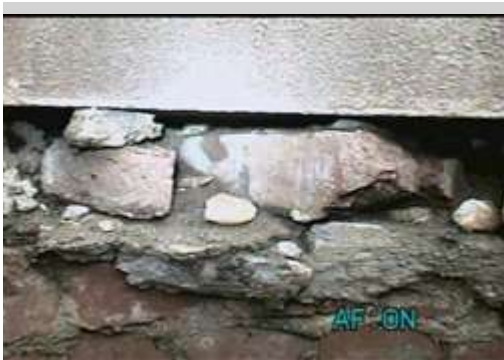
Defect 2

Condition: ☐ Sound ☐ Cracked ☐ Root Intrusion ☒ **Loose Brick** ☒ **Deteriorated**

corbel loose bricks and deteriorated

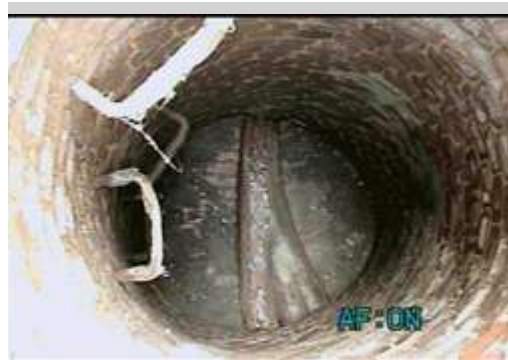
Defect 1

Steps Count: **5** Missing: **0** ☒ **Corroded**

corroded steps

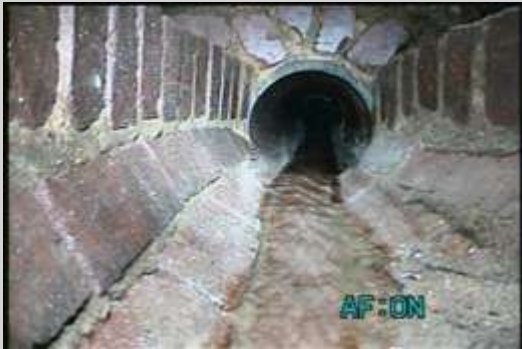
12 O'Clock Outflow

8 in. Circular Gravity Sewer
Pipe Out @ 12 O'Clock

Pipe Material: **Clay** ☐ Pipe Lined

Invert Depth: 11.30 (ft.) Flow Characteristics: **Fast**

Infiltration: **None** Pipe Seal Cond: **Unknown**

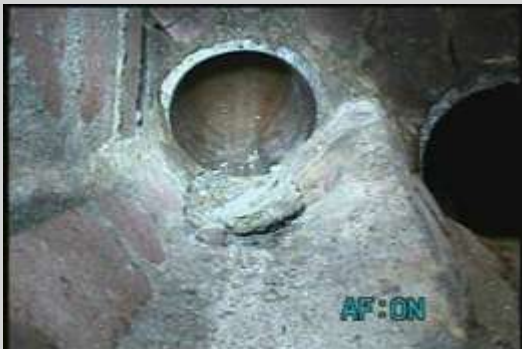
5 O'Clock Inflow

8 in. Circular Gravity Sewer
Pipe In @ 5 O'Clock

Pipe Material: **Clay** ☐ Pipe Lined

Invert Depth: 11.00 (ft.) Flow Characteristics: **None**

Infiltration: **None** Pipe Seal Cond: **Unknown**

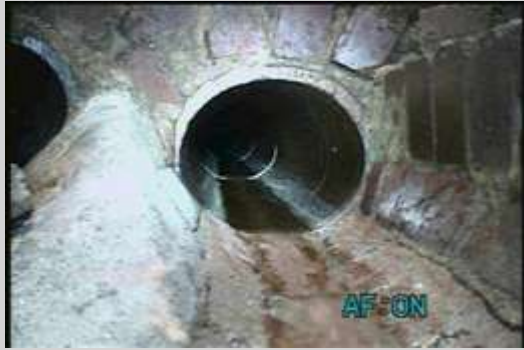
6 O'Clock Inflow

8 in. Circular Gravity Sewer

Pipe In @ 6 O'Clock

Pipe Material: **Clay** ☐ Pipe Lined

Invert Depth: **11.00** (ft.) Flow Characteristics: **Fast**

Infiltration: **None** Pipe Seal Cond: **Unknown**
